*Juan Santamaria International Airport
Rehabilitation Alternatives.*

**Mario Arce, PE
Pedro Castro, PE**

ISR & TAMS Consultants Inc.

September 1997

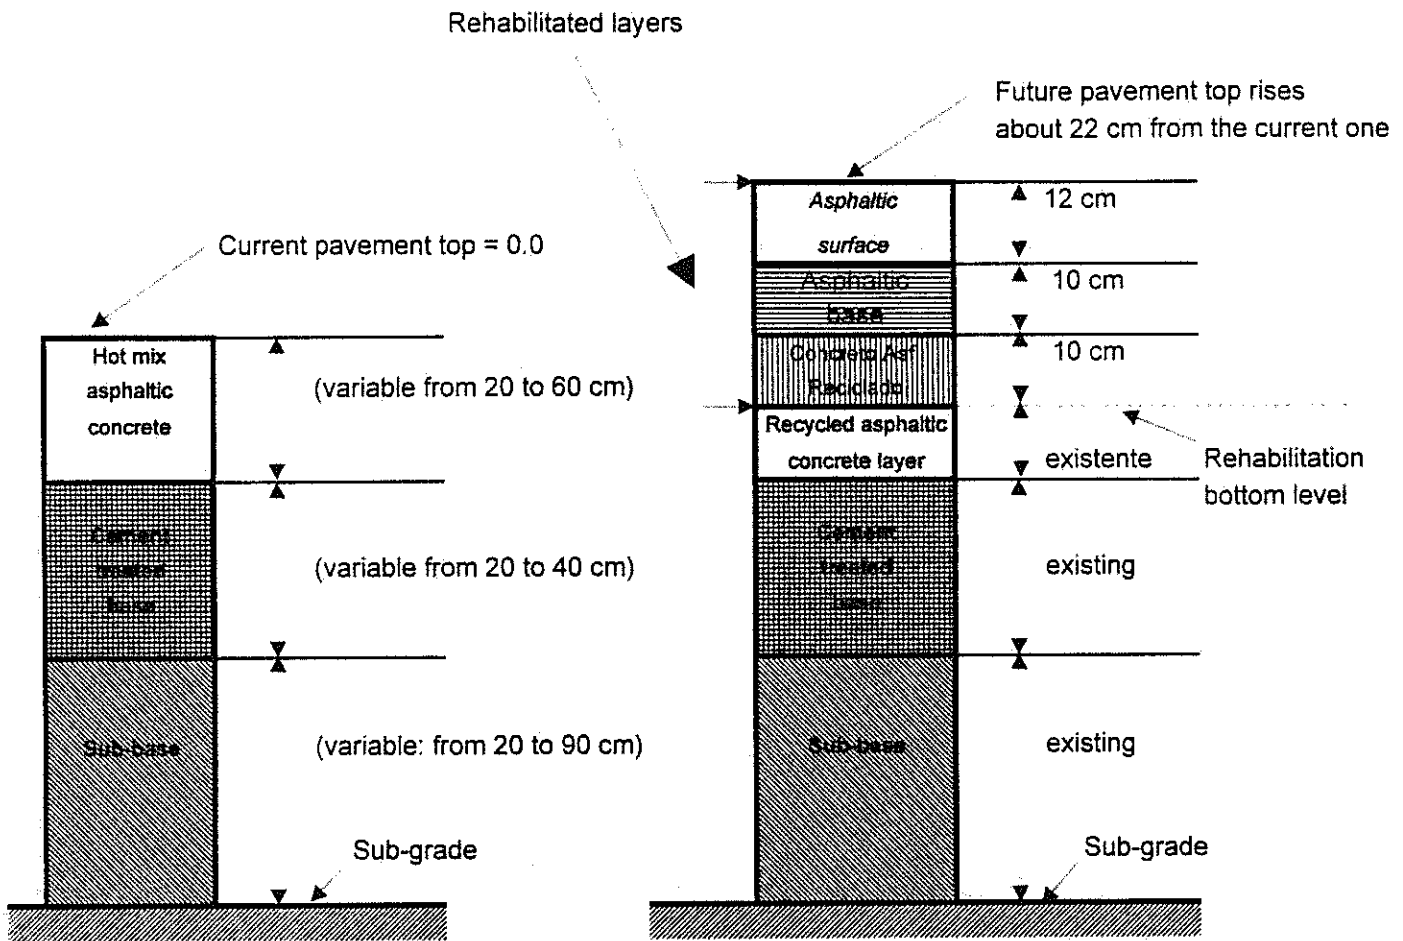
FIGURE 6.1: Run Way rehabilitation alternative (recycling and overlays).

EXISTING PAVEMENT

The existing pavement total thickness from 80 to 135 cm.

- Recycle top 10 cm asphaltic surface
- Place a 10 cm thick asphaltic surface
- Place a 12 cm thick asphaltic surface

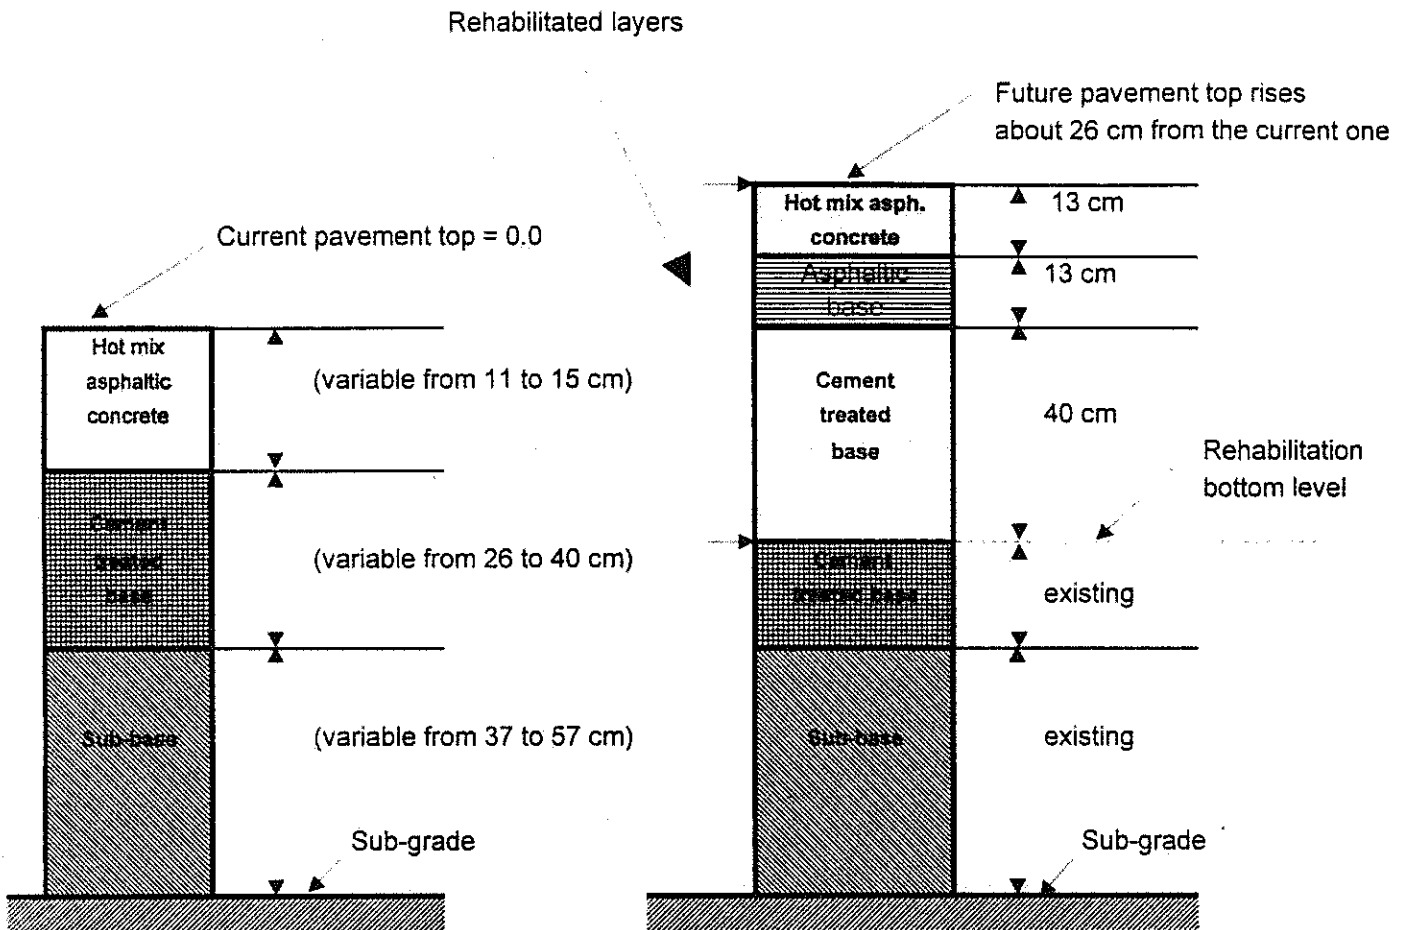
FIGURE 6.2: Taxy way rehabilitation alternative No. 1 (Flexible pavement)

EXISTING PAVEMENT

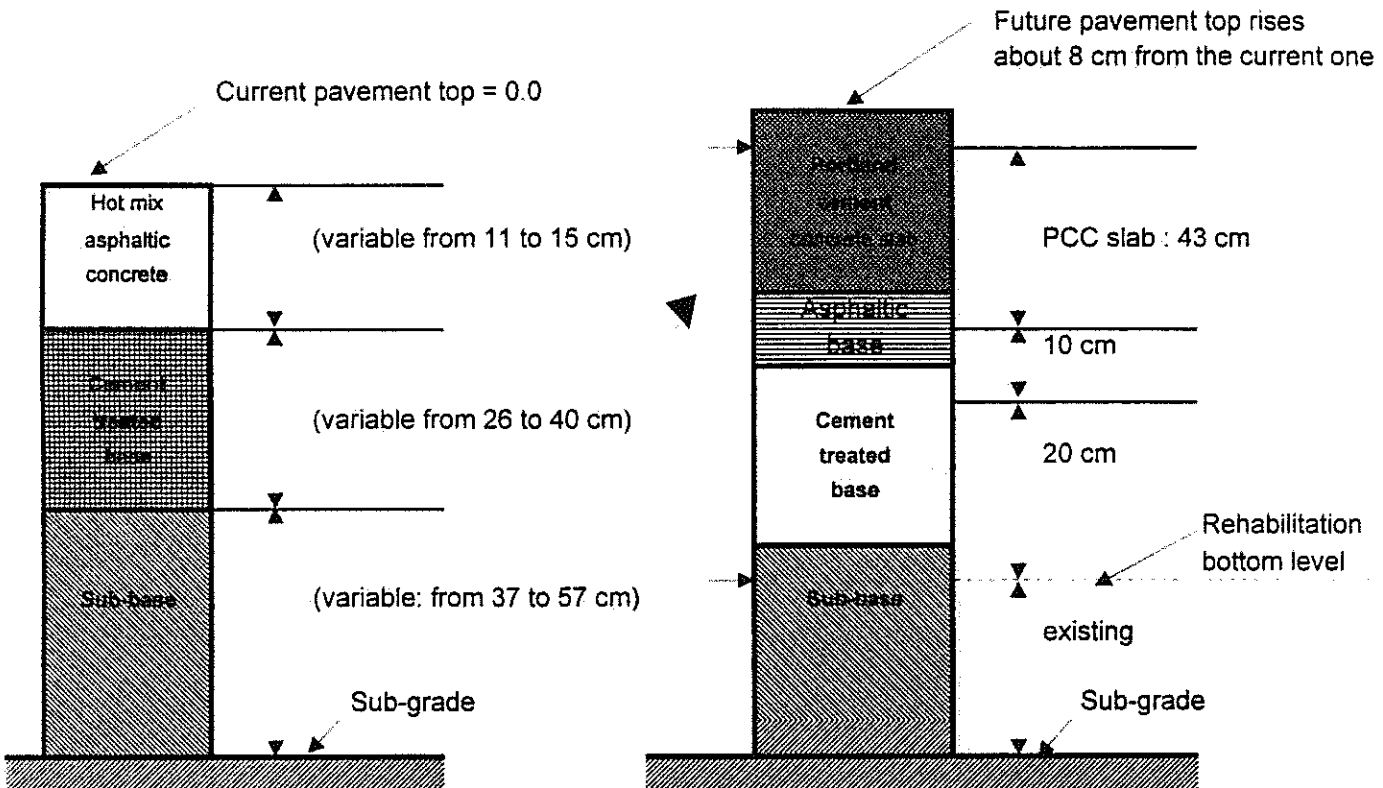
FIGURE 6.3: Taxy way rehabilitation alternative No. 2 (Rigid pavement)

EXISTING PAVEMENT

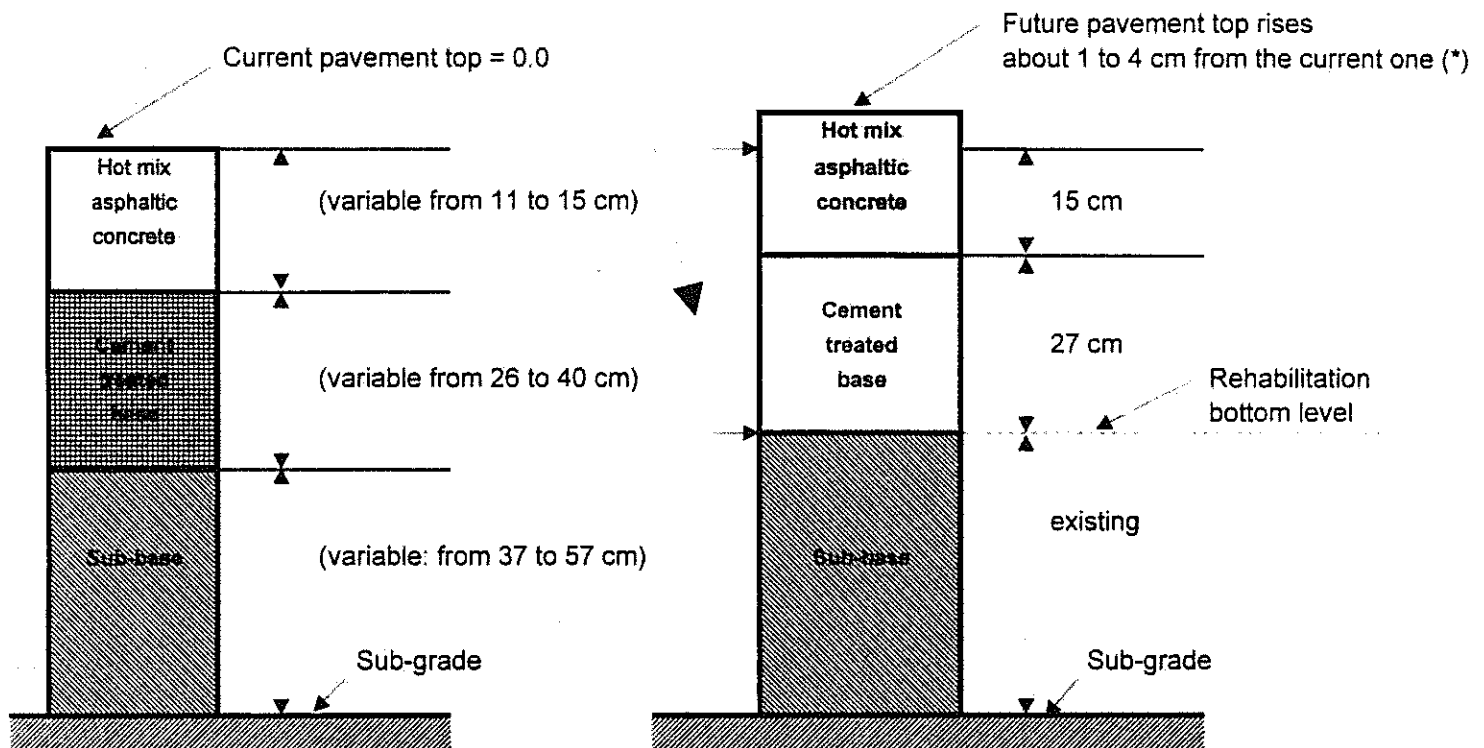
FIGURE 6.4: Taxy way rehabilitation alternative No. 2 (Sub-grade injection)

EXISTING PAVEMENT
