PREEMPTIVE
Feb 2019
San José, Costa Rica

COSTA RICAN CARIBBEAN COAST

CHIRRIPO BRIDGE

IDENTIFIED DAMAGES AT THE BRIDGE

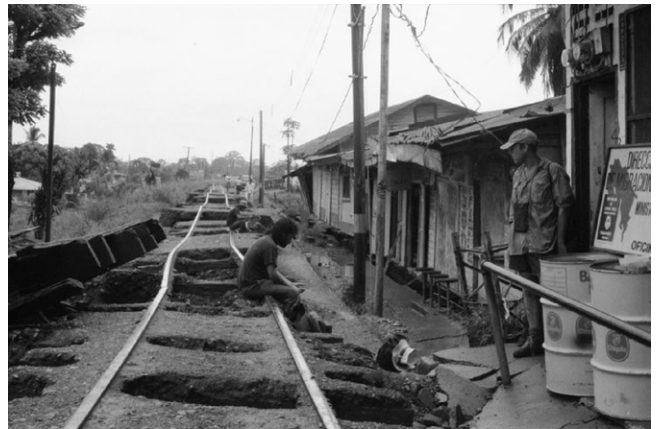
Damage caused by de Limon earthquake

The earthquake claimed 48 lives in Costa Rica and 79 in Bocas del Toro, Panama. There were 4 452 houses that collapsed in our country. Roads and bridges between Limon and Sixaola were all destroyed, and the epicentral region was only accessible by helicopter from the Panamanian side. It damaged 80% of Costa Rican territory and 20% in Panama. (RSN, 2017).

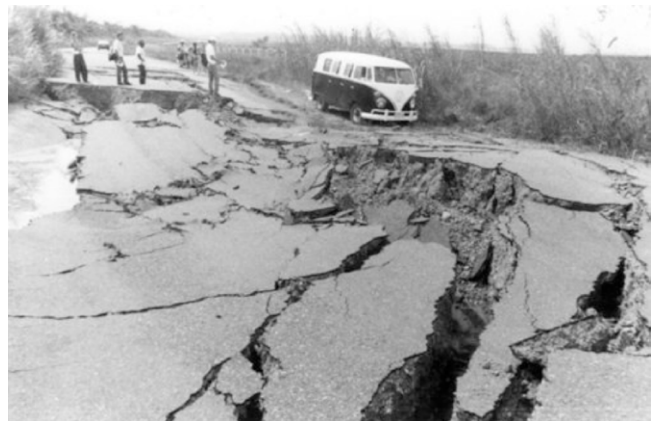
Liquefaction occurred by the natural disaster in 1991

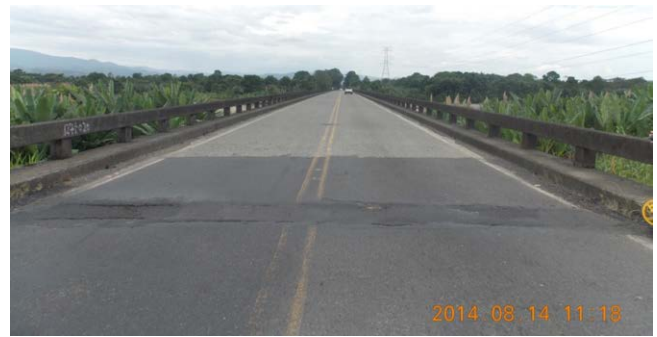
Longitudinal view of the Chirripó River Bridge.

The Chirripó bridge is located in Limón, has a length of approximately 471m, and a total width of 10.3 m of which 0.9 m correspond to the width of the sidewalk located on both sides of the bridge. Its structure was designed in 1969 and it was constructed between 1974-1978. The roadway surface is the same concrete slab of the superstructure.

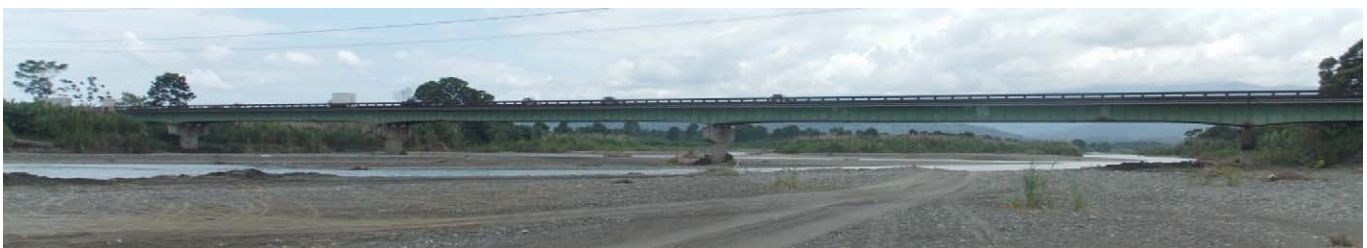
Lateral view of the Chirripó River Bridge.

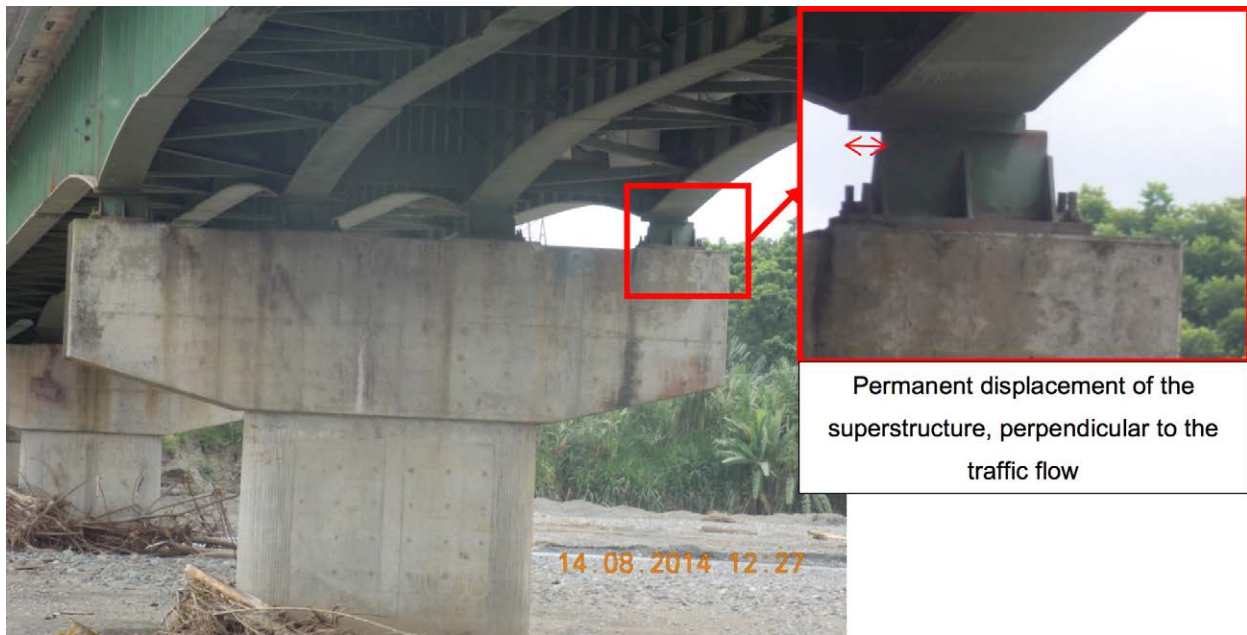
View of the Pier 3 from the east side.

- The majority of the metallic bearings on Piers 2, 3, 4 and 5 are not completely attached to the superstructure (which is continuous over these piers). Also, the bolted connections no longer have the nuts.

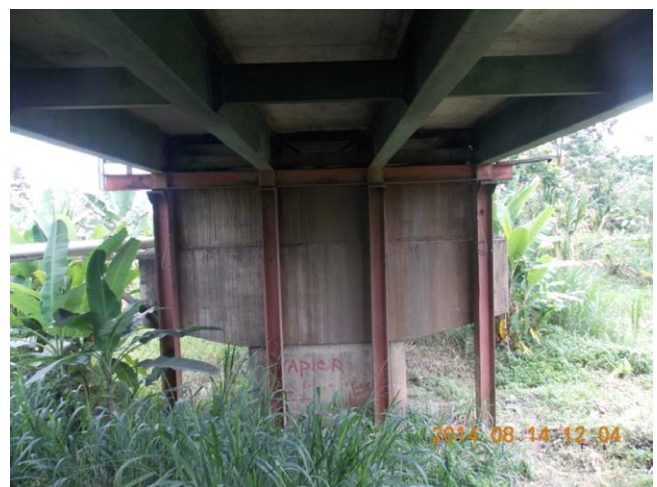
Metallic support structure built after the earthquake to prevent collapse of Superstructure 2.

- The bearings of Superstructure 2 over Abutment 2 are displaced with respect to its lower steel plate.
- The concrete of the pedestal on Pier 7 is detached. This caused a reduction on the bearing length. Therefore, an additional metallic supporting frame structure was built in order to avoid collapse of Superstructure 2. This structure was meant to be temporary but it already has signs of corrosion.

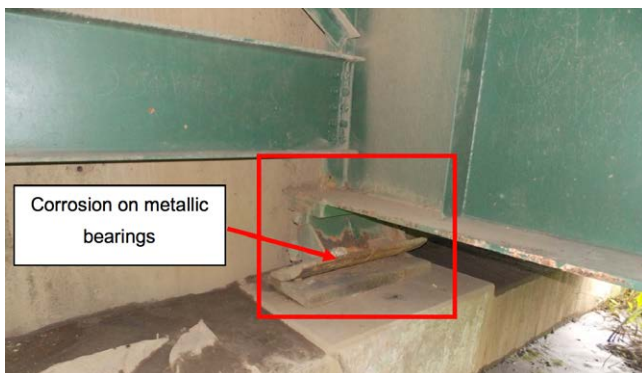
Rocking bearing tilted towards the headwall and corrosion found on Pier 1.

- The metallic bearings (rocker type) were tilted towards the headwall on Pier 1 and towards the pedestal on Pier 7, because of the longitudinal forces induced by the 1991 Limon Earthquake. This causes that there is contact between the girders and the headwalls in both piers.

- Corrosion was found in all the bearings, at different levels. In the central piles, there is slight signs of corrosion; at Piers 1 and 7, there is loss of section on the bearings because of the continuous flow of water through the expansion joints.

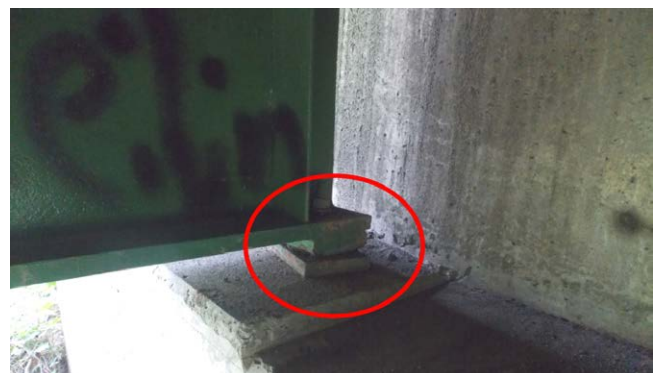
Displaced bearing on Abutment 2.
