PREEMPTIVE
Feb 2019
San José, Costa Rica

The earthquake was felt in all Costa Rican territory as well in Nicaragua, Guatemala, El Salvador and Panama. The depth of its epicenter was at 15.4 km and was caused by the subsidence between Cocos and Caribbean plate. Apparently, there were around 540 aftershocks following the quake. Most of them between 3 and 5 on the Richter Scale, which is pretty typical after a tremor of this magnitude. The seismic energy released was of approximately 158 atomic bombs just like the one of Hiroshima on 1945. Some effects of this event are destroyed houses, including broken windows, cracks on walls, and materials detached from the buildings, also some roads were closed and schools closed for precaution. (RSN, 2015)

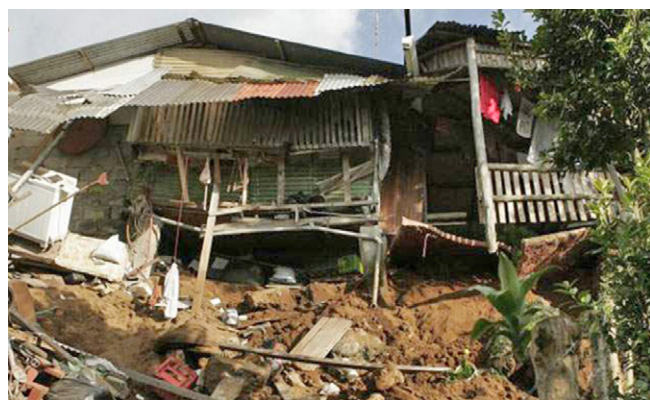
Figure 2. House affected by Cobano earthquake in 1990

The 1990 C bano Earthquake occurred on March 25, at 7:22 am local time. The depth of its epicenter was at 24.2 km and its magnitude was around the 6.9 Ms (7.0 Mw). The people of Puntarenas and C bano where affected the most. They reported 32 damaged houses, 8 destroyed and 79 buildings. There were no reports of deaths, but as consequence, there were different coastal zones that had problems of liquefaction on roads and lands (Santana, 1990).

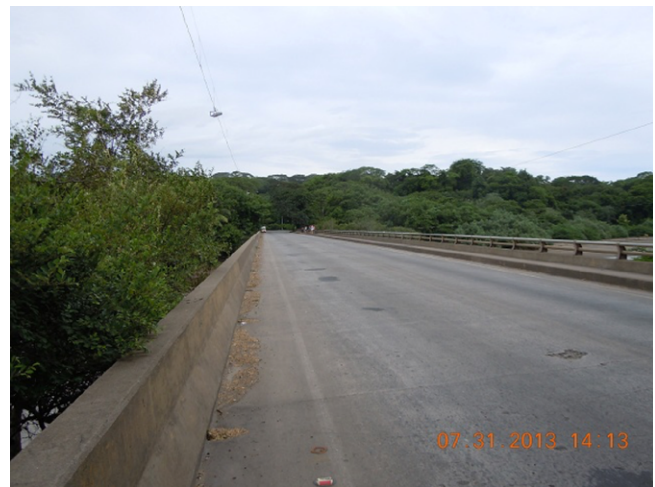
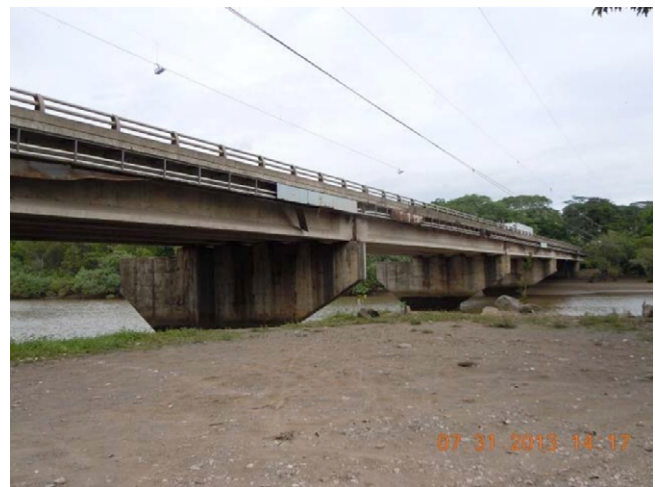
Figure 4. Longitudinal and lateral view of the Barranca bridge

Table 1. Characteristics of the Barranca Bridge

Geometry	Total length	178,7 m
	Total width	10,7 m
	Width of road	9,0 m
	Number of spans	5
Super-structure	Type of principal elements	Simply supported concrete "T" beams
	Type of road surface	Concrete reinforced slab
	Number of elements	Abutments: 2 Piers: 4
Substructure	Type of piers	Concrete reinforced column
	Foundation	Piles

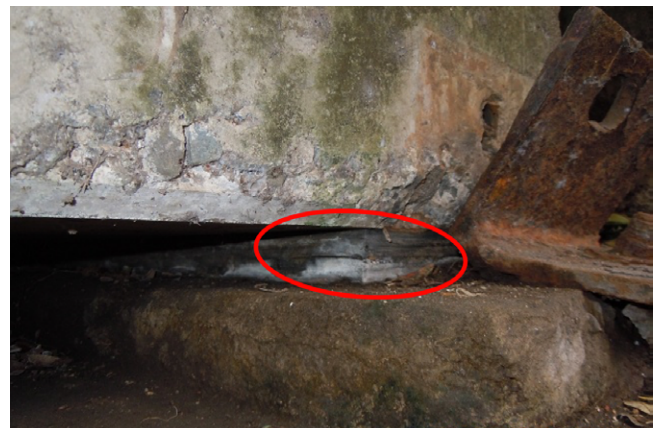
Crack on the neoprene pad on a bearing at Abutment No. 2

- Shear failure on the bolts of the bearings
- Permanent deformation or cracking of the neoprene pad
- Degradation of the concrete, cover detachment and exposed rebar
- Bearing pedestals with cracks or concrete detachment

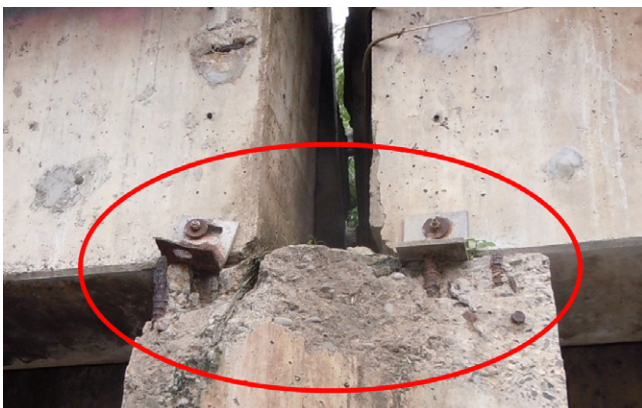
Damage on Pier No. 4. There is no connection between bolt and the bearing's steel angle, as well as cover detachment.

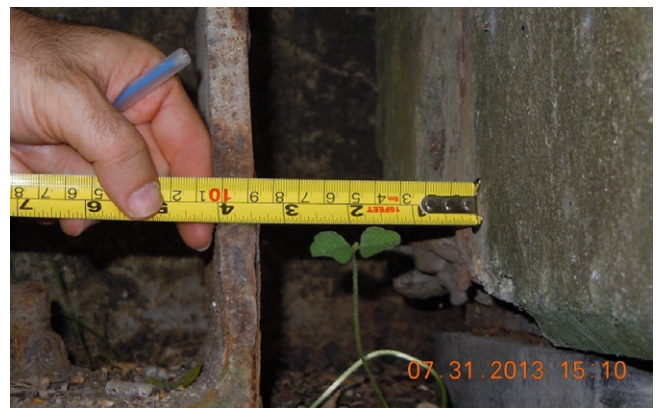
Transverse displacement of the Superstructure No. 5 over the Abutment No. 2. There is failure of the bolt, corrosion of the steel angle and evidence of water filtration.

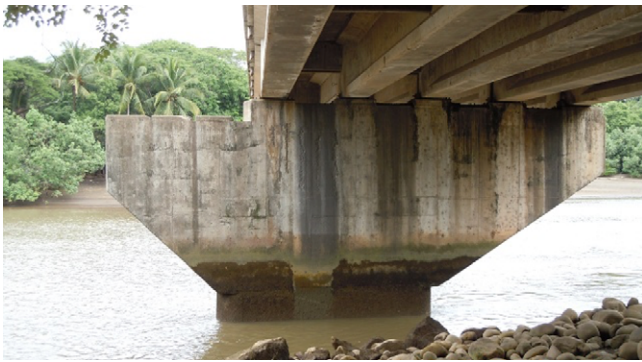
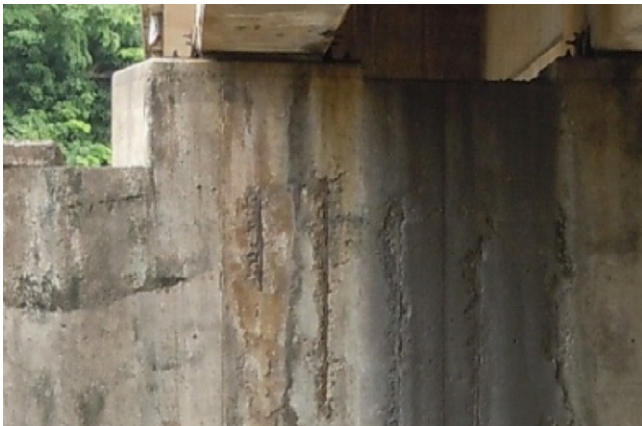
Damage on north side of Pier No. 1.
There is no cover and therefore the rebar is exposed.

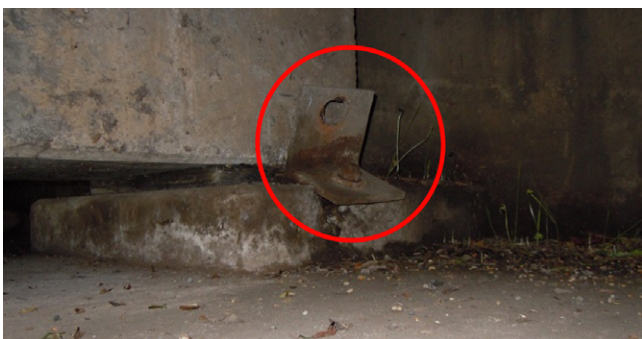
Damage on the bolts of a pedestal of Abutment No. 2,
induced by the lateral force of the girders.
