Evaluation of Transverse Thermoplastic Pavement Markings for Speed Reduction in Costa Rica

**Javier Zamora-Rojas, P.Eng., MScE
PITRA-LanammeUCR, University of Costa Rica**

Abstract

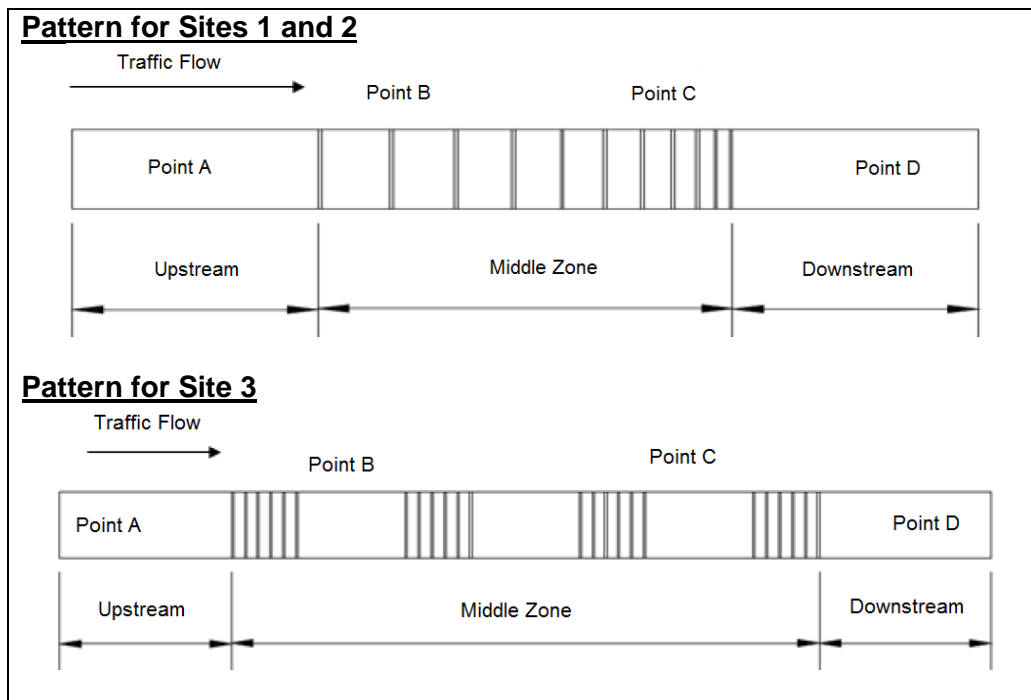
Figure 1 – Transverse pavement marking patterns tested in Costa Rica.

Three sites were selected for the installation of transverse pavement markings, and two different patterns were designed, installed and tested. For both designs, full lane width transversal lines were proposed, but with a different spacing design. Peripheral markings were not included in the test, as well as any other alternative transverse marking patterns.

In terms of spacing design, the first two sites followed a progressively narrower logarithmic spacing pattern, and for the third site, the pattern consisted of four equally-spaced groups of six equally-spaced bars, as shown in Figure 1. Equation 1 was used to obtain the spacing of the lines for the logarithmic pattern. In the equation, x is the number of line (from 1 to 25) and y is the spacing in meters. This equation corresponds to a theoretical speed reduction of 40 km/h.

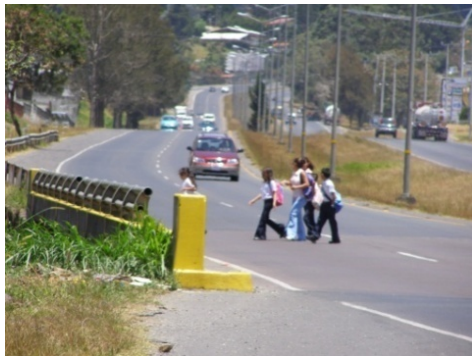
Figure 2 – Pedestrians crossing the highway at Site 1.

more than 110 pedestrians were counted crossing the highway at this point (Figure 2), including schoolchildren and parents with babies on strollers. There are residential areas and schools close to both sides of the highway. At this point there are no pedestrian facilities, and there is an evident need to cross the highway. Transverse lines with a progressively narrower logarithmic spacing were installed in the westbound direction (Figure 3) in order to mainly increase alertness on drivers, and maybe encourage speed reduction, which would have an impact on the risk to pedestrians needing to cross at this point. Speeds tend to be higher in this highway section due to a smooth road alignment (Figure 4).

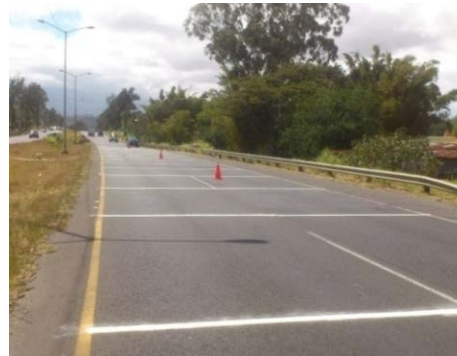
Figure 3 – Installation of markings at Site 1.

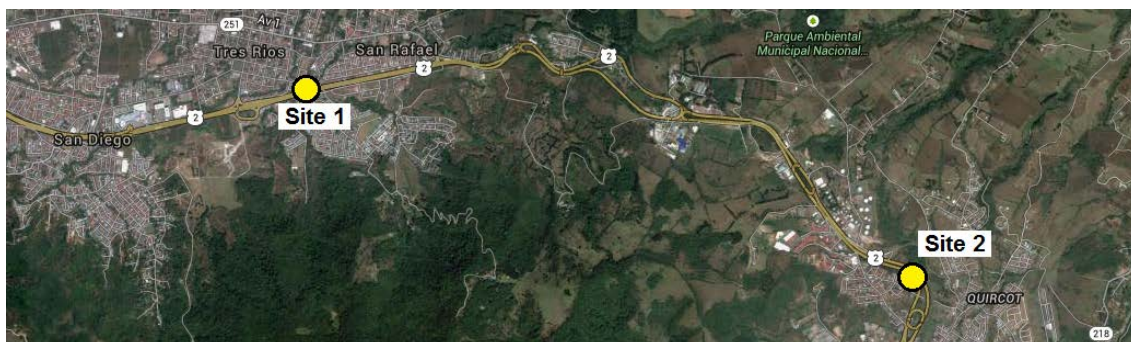
Figure 4 – Location of testing sites 1 and 2 (aerial view)

Site 2. Located on the same 4-lane divided highway as site 1 (Figure 4), with a distance of about 6 km from Site 1, but in the opposite direction (eastbound), this section carries over 45,000 vehicles per day (year 2012). In this highway, heavy vehicles represent 18 to 21% of the average daily traffic (ADT). The specific location is a downgrade slope right before a sharp horizontal curve (Figure 5), reason why the posted speed drops to 60 km/h in this section. This site was selected due mainly to its road alignment, which is not consistent with the operating speeds. Transverse lines with progressively narrower logarithmic spacing were installed (same as Site 1). A total of 25 transverse lines were placed in each site, with spacings varying from 16 m to 2.5 m at the end of the speed zone, as it can be appreciated in Figure 5. Agent [7] had tested transverse markings in Kentucky, USA, in a sharp horizontal curve, achieving a maximum speed reduction of 25 km/h; although a novelty effect was also observed.

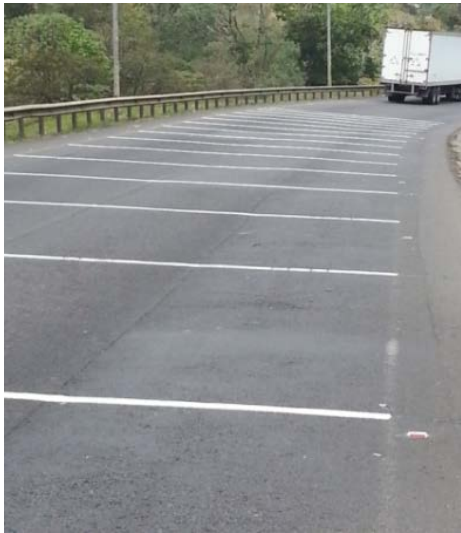
Figure 5 – Installation of markings at Sites 2.

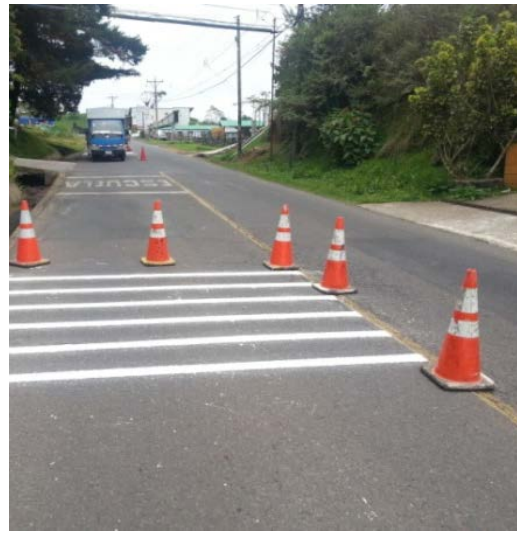
Figure 6 – Installation of markings at Sites 3.

Site 3. The third site is located in a rural two-lane low-traffic mountainous road, specifically in a road section with moderate slopes and horizontal curves, with a posted speed of 40 km/h. This road has an average daily traffic of about 3,000 vehicles per day, with an 18% of heavy vehicles (yr. 2012). A different pattern was tested, which consisted of four groups of transverse lines installed with a separation of 30 m between groups. Each group consisted of six lines with a constant spacing of 0.5 m (Figure 6).
