University of Nevada, Reno

Reflective Cracking of Flexible Pavements: Literature Review, Analysis Models, and Testing Methods

May, 2008

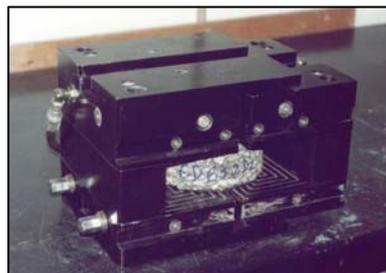
Figure 4.3 (a) Bottom platens of the reflective cracking device
 (b) Reflective cracking device with both (top and bottom) plates

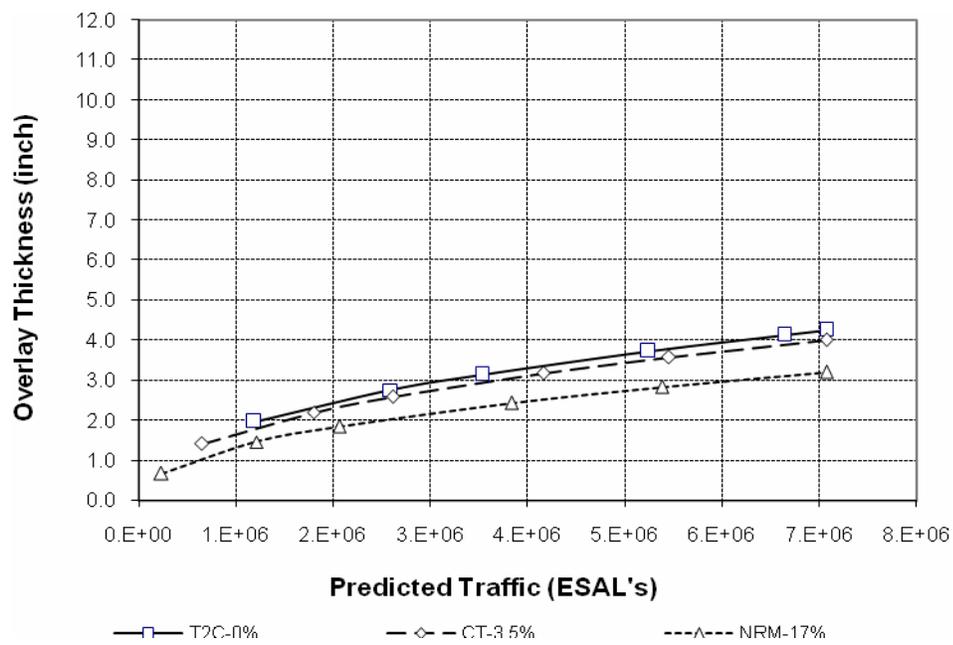
Figure 4.10 NRM required overlay thickness according to the asphalt rubber method

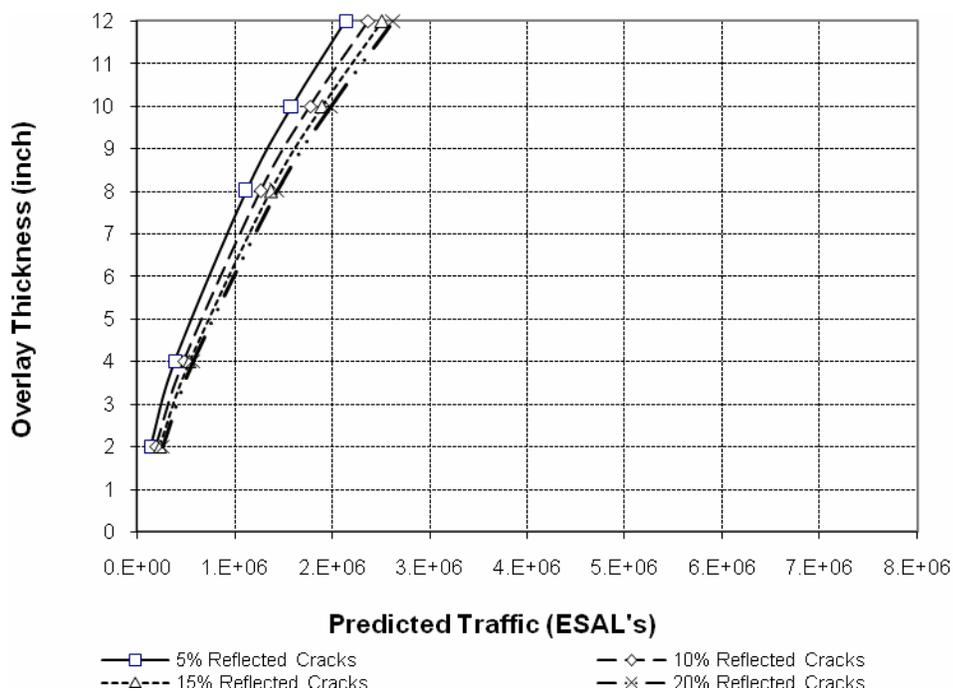
Figure 4.11 Overlay thickness according to the asphalt rubber method for selected percent cracking

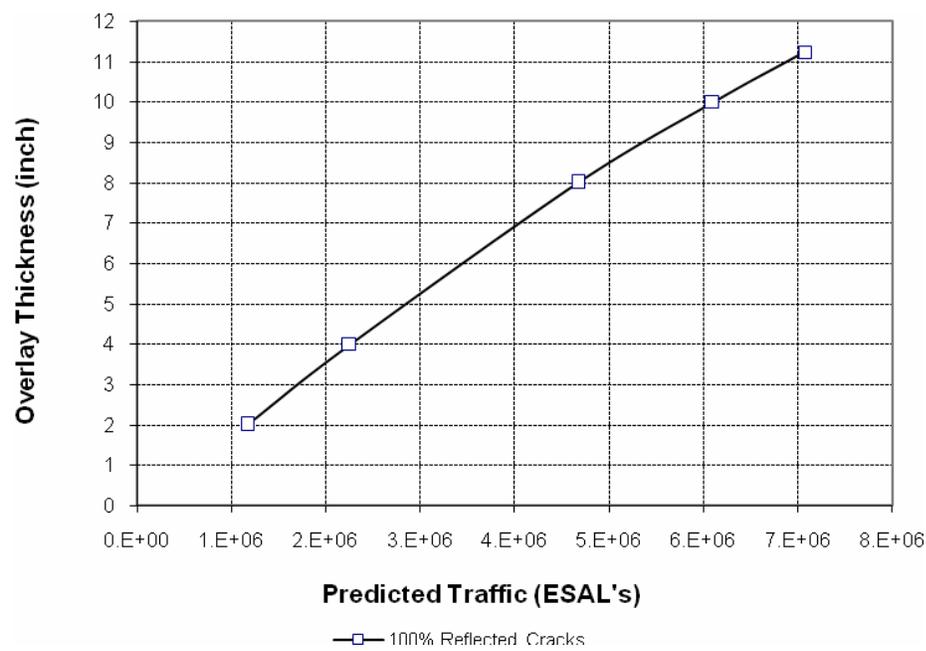
Figure 4.12 Required overlay thickness according to the new AASHTO method

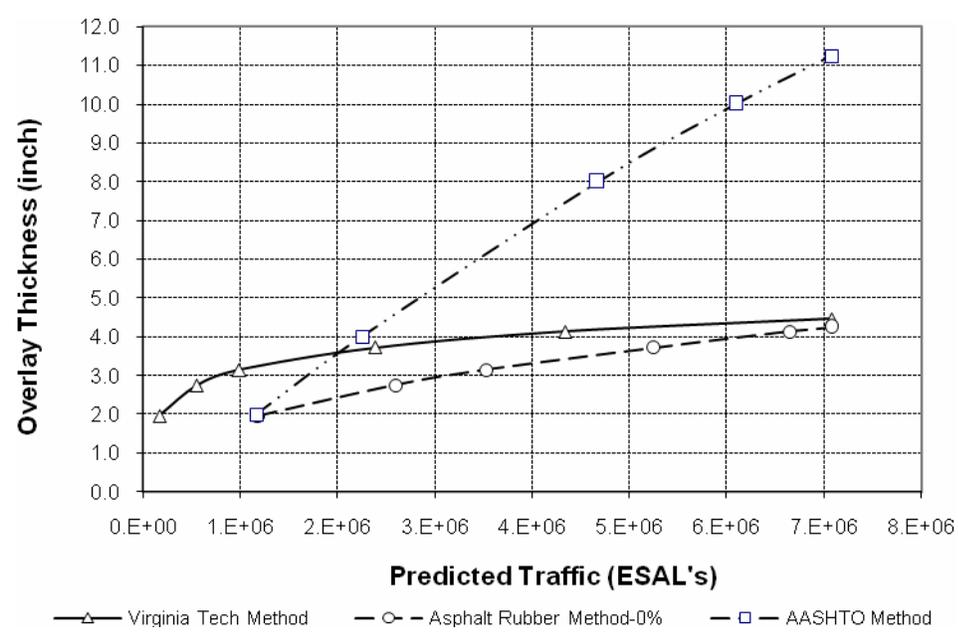
Figure 4.13 Required overlay thickness according to the new AASHTO method for 100% reflected cracks

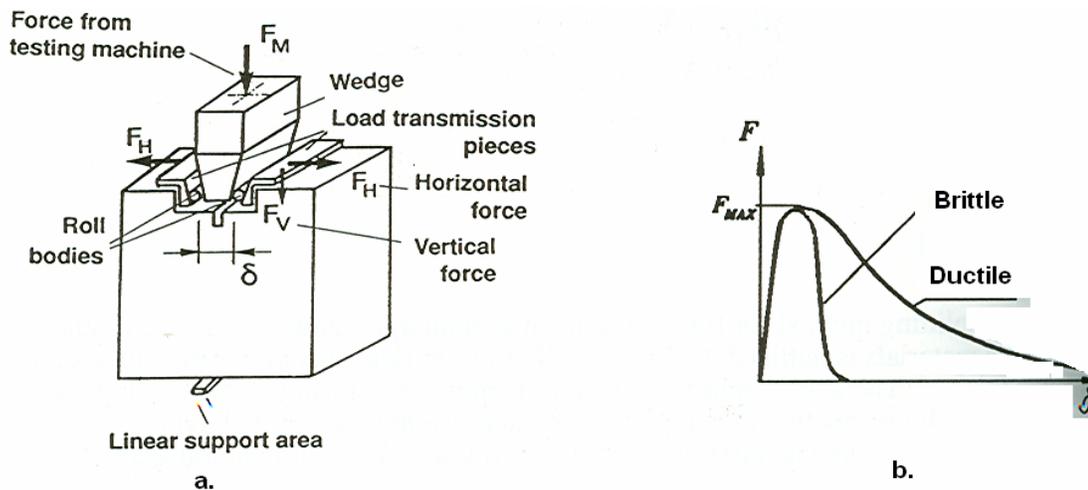
Figure 5.7 Fissurometer apparatus description

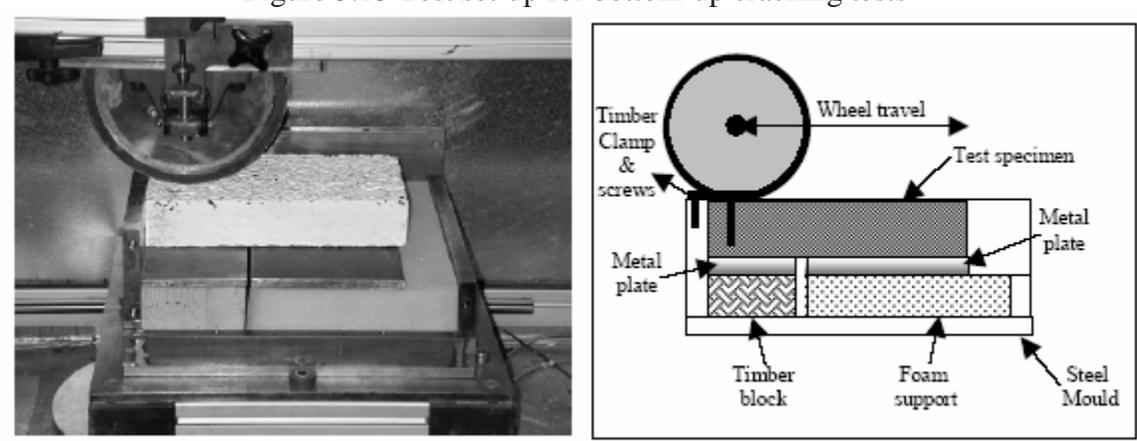
Figure 5.15 Test set-up for bottom-up cracking tests

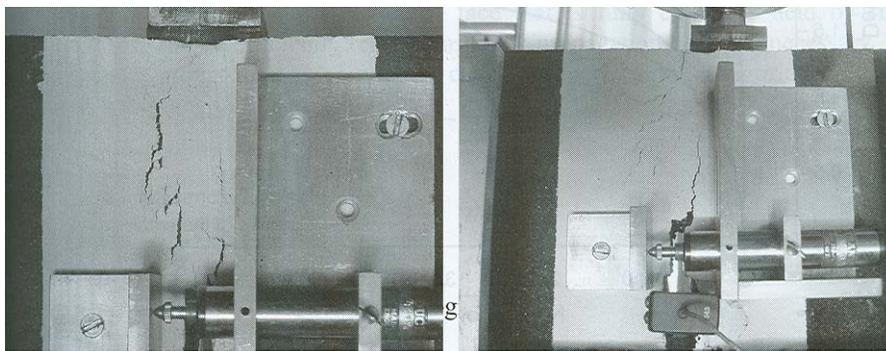
Figure 5.21 Cracking pattern at the end of test – beam without geogrid

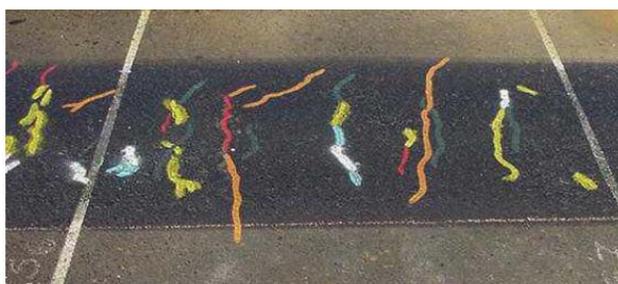
Figure 5.44 Failed HMA layer cracking pattern
