*Juan Santamaria International Airport
Rehabilitation Alternatives.*

**Mario Arce, PE
Pedro Castro, PE**

ISR & TAMS Consultants Inc.

September 1997

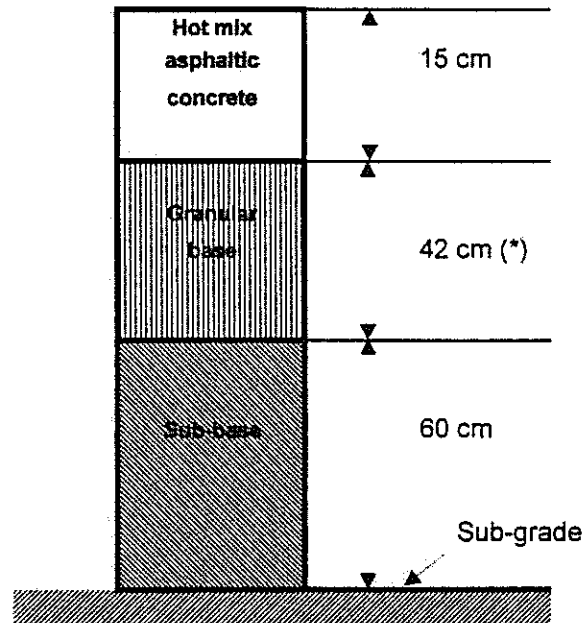
FIGURE 6.6: New flexible pavement, with granular base (alternative No. 1)

(*) Due to the high variability among current asphaltic surface thicknesses.

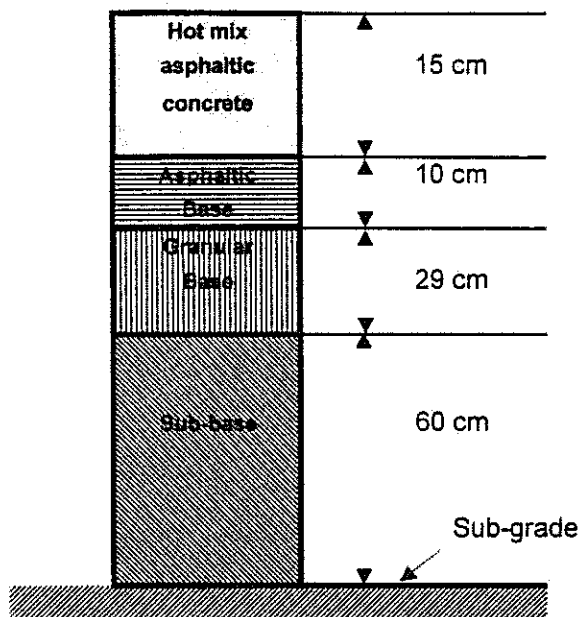
FIGURE 6.7: New flexible pavement, with asphaltic base (alternative No. 2)

(*) This thickness may be decreased if a cement treated base is built
5% CBR sub-grade material

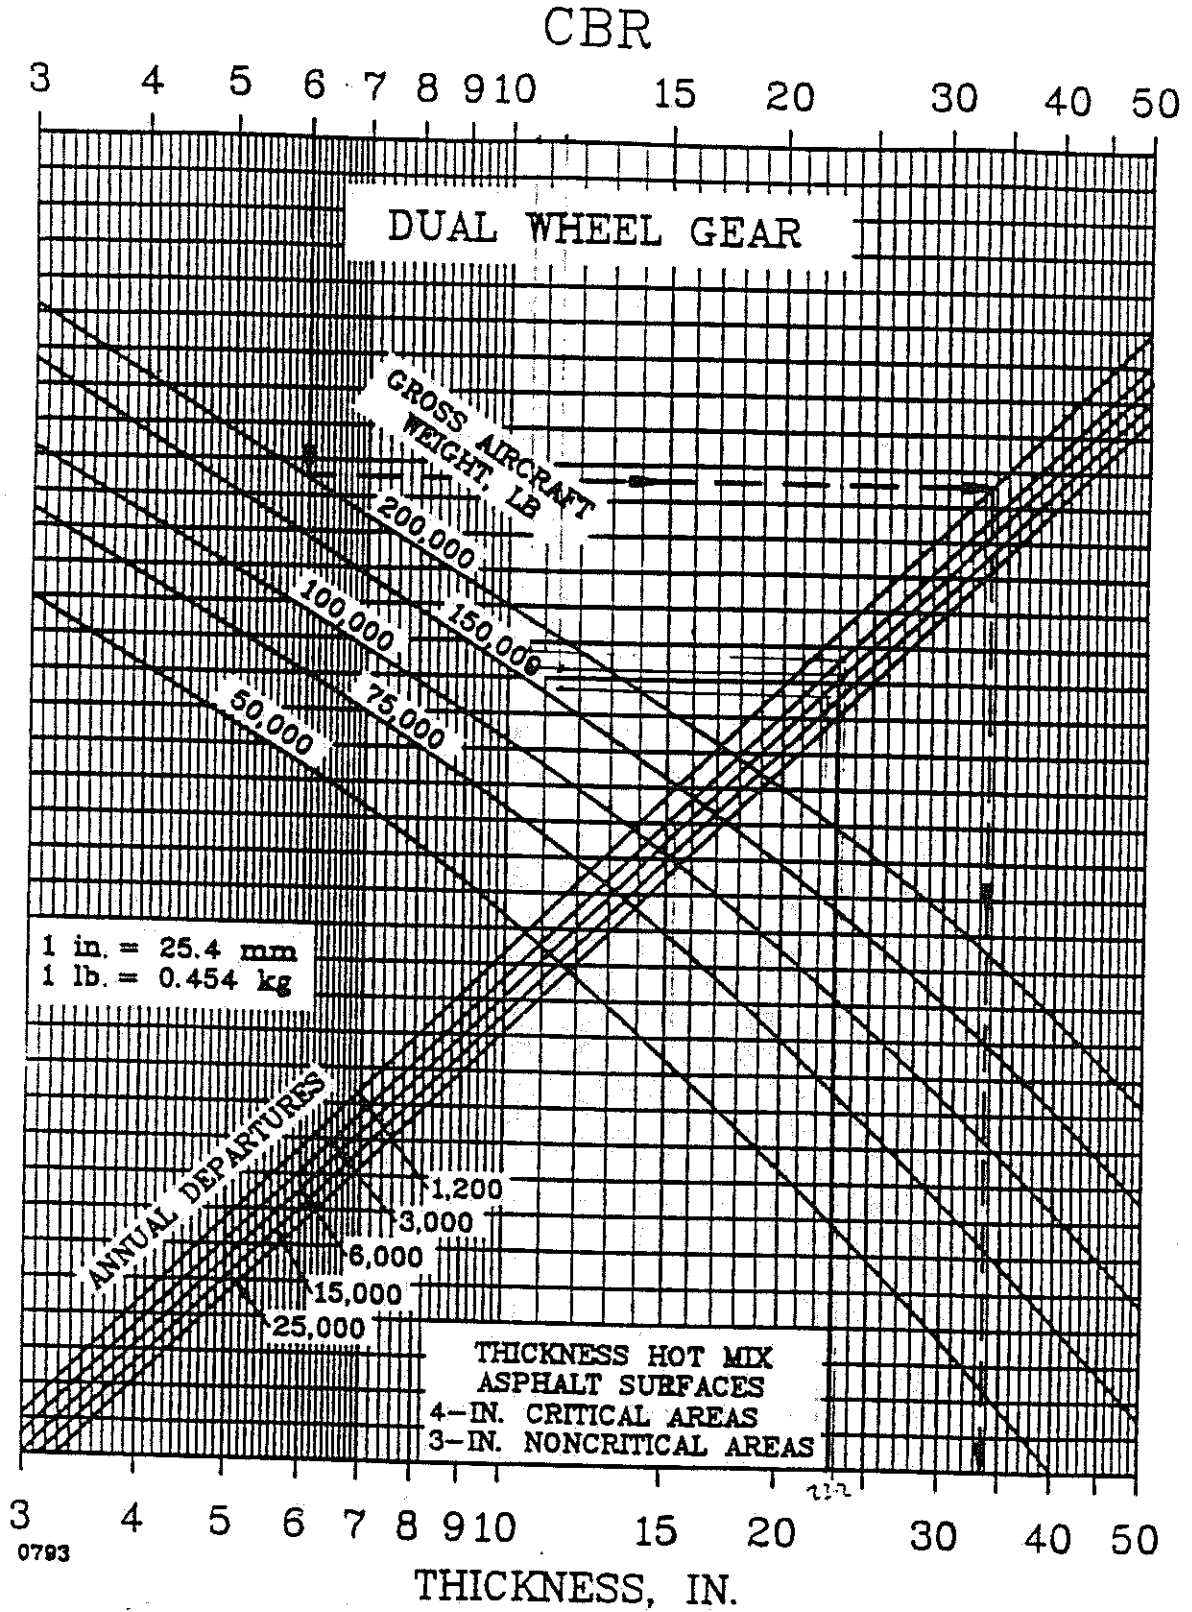
FIGURE 3-3 FLEXIBLE PAVEMENT DESIGN CURVES, DUAL WHEEL GEAR

According to Figure No. 3-3 (Appendix 3, corresponding to a dual tandem landing gear), on circular No. 150/5320-6D (Ref. 1), using a sub-grade CBR of 3 %, a gross weight of 95200 kg (209439 lb), and 10652 equivalent annual departures, the required total pavement thickness is 147 cm (58 in).

According to the design diagram (Figure No. 3-3), the minimum asphaltic surface thickness is 10 cm (4 in). Nevertheless, this thickness has to be adjusted by distress condition and design safety considerations. Consequently, a 15 cm thick asphaltic surface is proposed.

From Figure No. 3-3 in FAA circular No. 150/5320-6D (Ref. 1), assuming a 10 % CBR sub-grade (result of an electro-chemical injection), a total pavement thickness of 76 cm (29.5 in) is determined.

Figure No. 3-3 establishes a minimum asphaltic surface of 10 cm (4 in). Nevertheless, due to design safety considerations and maintenance interference reduction, it is strongly recommended to build a 15 cm thick asphaltic surface instead.

According to Figure No. 3-3, from FAA circular No. 150/5320-6D (Ref. 1), for a 5 % CBR subgrade, design airplane gross weight of 95200 kg (209439 lb) and 10652 equivalent annual departures, the required total pavement thickness is 117 cm (45 in).

Considering a 15 % CBR sub-base (Ref. 7), and following the mentioned design chart (Figure No. 3-3), the required thickness for both base and asphaltic surface together is 57 cm (22.5 in).
